CASE STUDY:
WREXHAM POLICE STATION
WALES, UK

GP[®]1 provides protective ground gas barrier solution for Wrexham Police Station

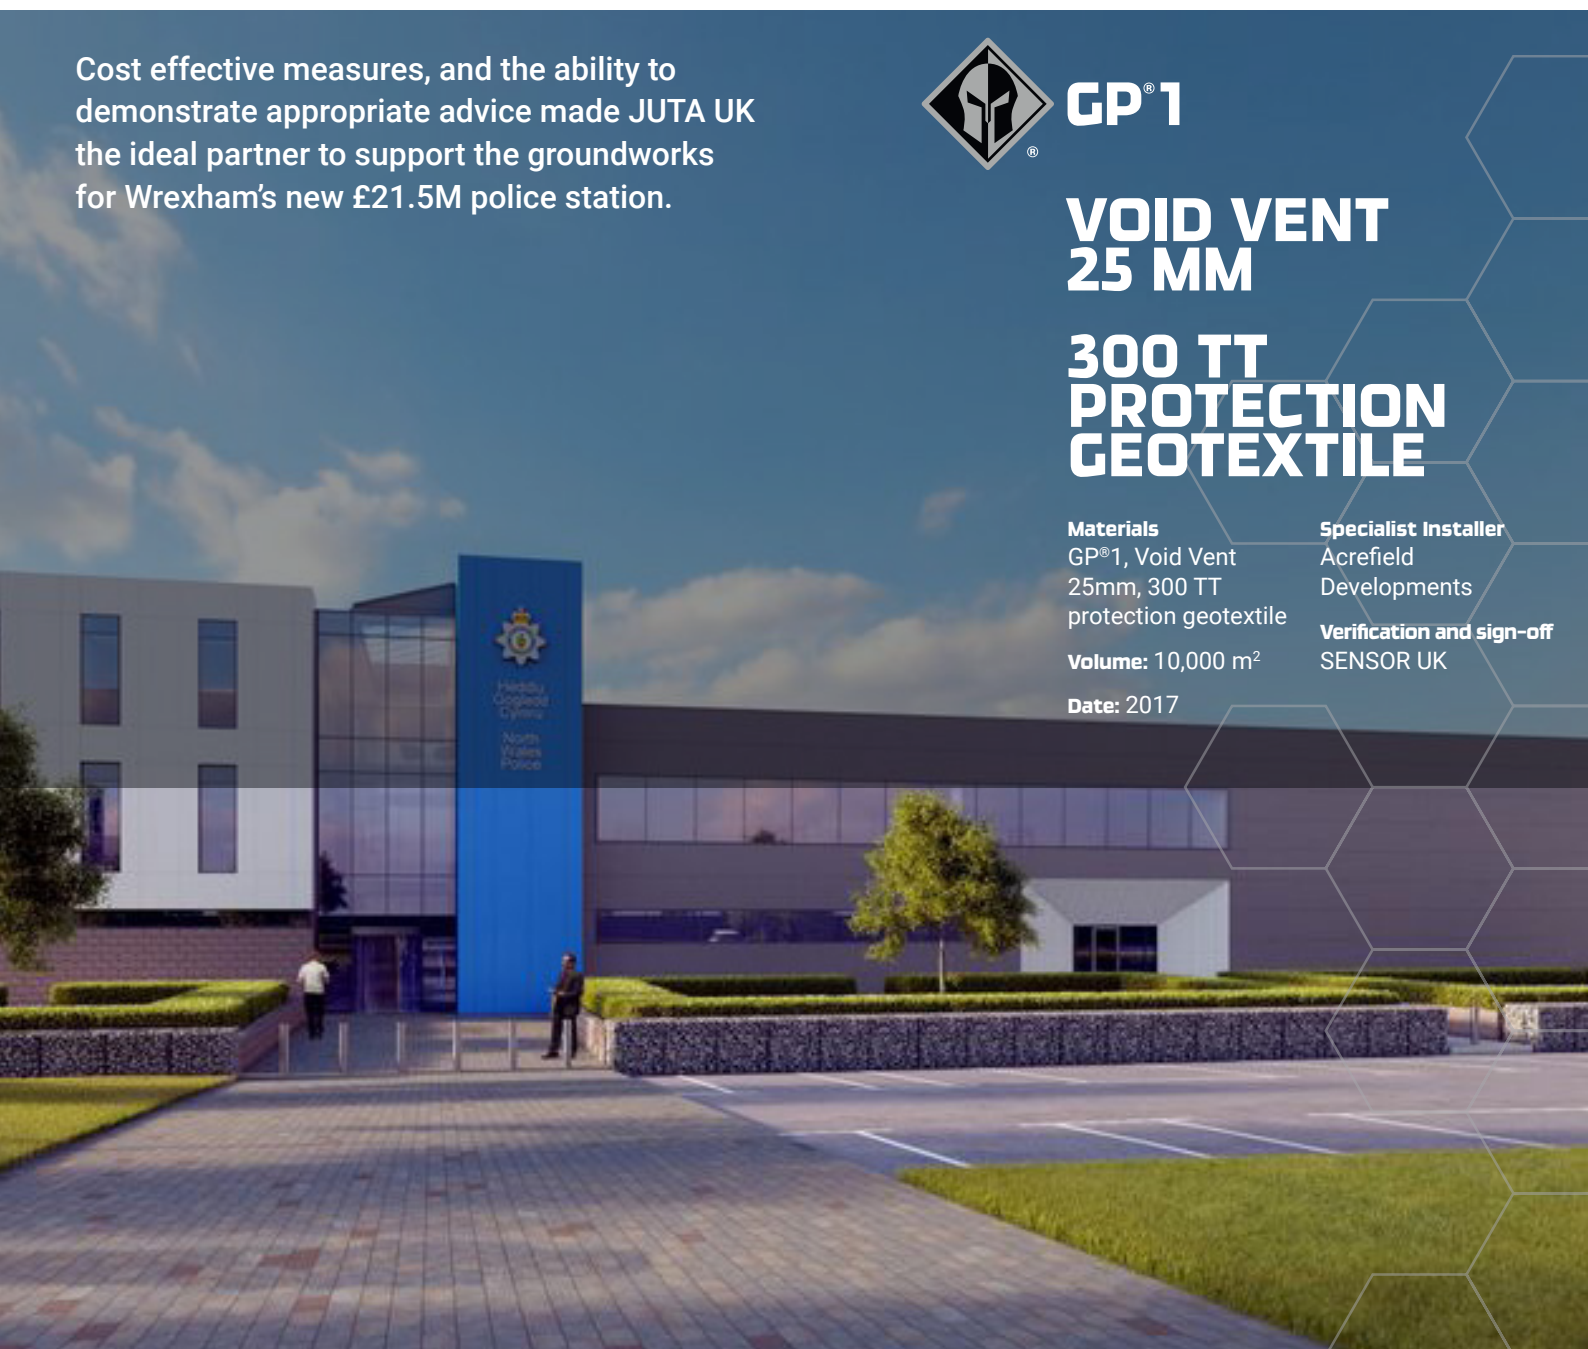
GP[®]1

**VOID VENT
25 MM**

**300 TT
PROTECTION
GEOTEXTILE**

A nominal underfloor venting system was also required to prevent gas becoming trapped below the floor slab. Void Vent 25 - a 25mm deep cusped geocomposite - was installed in designed 'strips', to provide a pressure relief below the slab, and provide a 'path of least resistance' for any migrating ground gas, allowing it to

A protective geotextile (300TT) was also included in the design, to be placed above the compacted subgrade to prevent damage to the GP®1 from underlying sharp materials. One thing we see removed often from gas membrane installation works is the protective geotextiles.
